SBE21

DRAFT PAPER

Deep renovation of an old single-family house including application of an water repellent agent – a case story

E J de Place Hansen^{1,2}, T K Hansen¹ and V Soulios¹

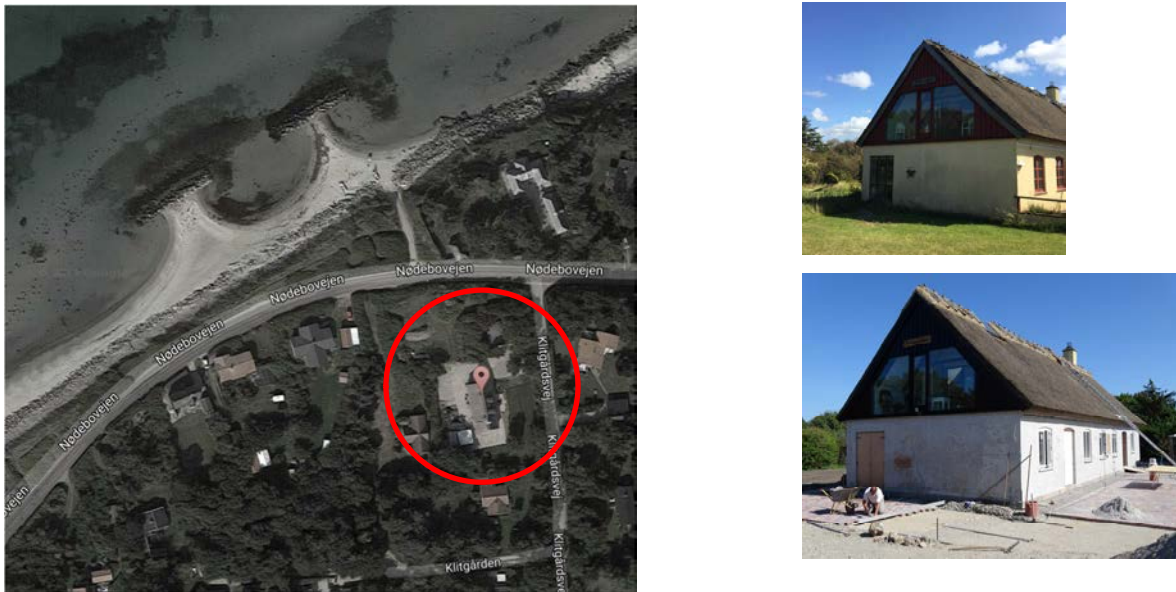
The case building, originally part of a farm with four buildings around a square, is located in Hundested, a minor town close to the sea at Northern coast of Zealand, about 70 km NW of Copenhagen, Denmark. The site is situated outside the city centre in rural area and in the first row to the sea, though a bit farther away from the sea than nearby houses (Figure 1, left). Especially at the NW corner, wind-driven rain and sea fog is observed by the owner.

Figure 1. Left: Location of Klitgaarden, 100 m from the Northern coast of Zealand, Denmark. Right: North gable of the building before (top) and after renovation (bottom). As part of the renovation, the vegetation around the house was replaced by pavements of bricks. Photos (right): Thomas Svendsen.

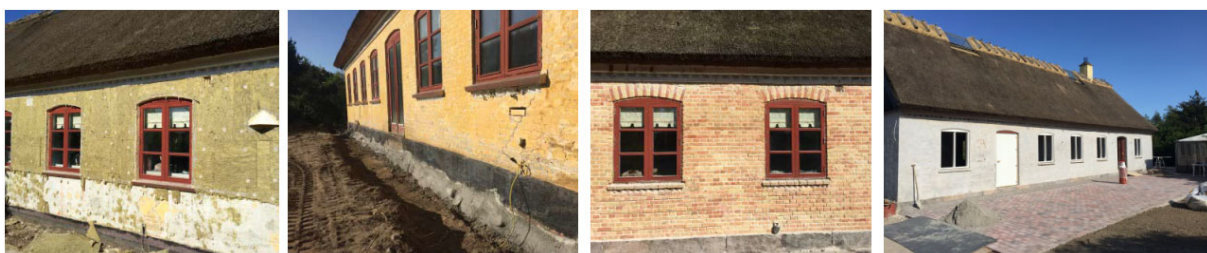
Figure 2. Exterior façade of the building during renovation. Left: exterior insulation removal, mid-left: added protection (sand and concrete) to the foundation, mid-right: cleaned brickwork, right: facade with washed mortar applied. Photos: Thomas Svendsen.

After removing the external insulation, the exterior surface of the walls was sandblasted and plastered with a thin layer of bank sand mortar (mortar washed), with exception of the southern gable where the wall condition required eight millimetres of plaster. Both the façades and the gable walls were internally insulated with 80 mm PUR-foam with channels filled with capillary active material (iQ-Therm) and a thermal conductivity of 0,031 W/(m K), reducing the U-value of the original wall from 1,2 W/(m K) (without the later added external insulation) to 0,3 W/(m K) on the façade. Similar effect on the gable walls. The interior surface is given by the insulation system as a painted plaster (diffusion open). After renovation, the external walls were 471 mm (façades) and 351 mm (gables) thick, respectively. Two years later, a water repellent agent (type Funcosil Remmers FC cream 40%) was applied with a paint roller in the specified amounts of 0.15–0.20 l/m² [1].

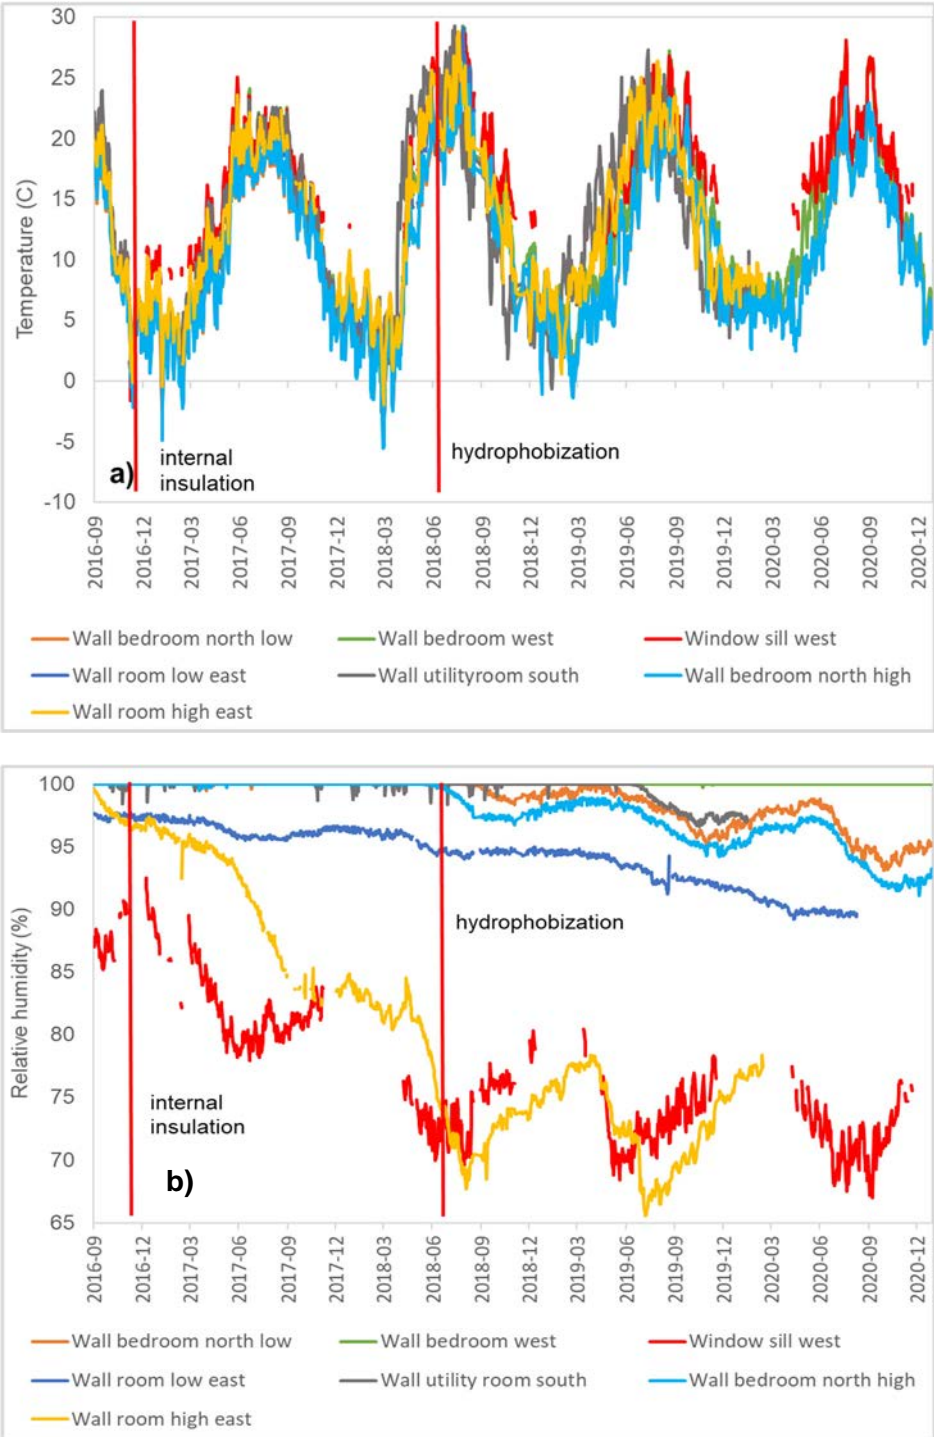
Figure 5. Temperature (a) and relative humidity (b) at the interface between the original wall and the internal insulation and at the window sill (red curve) (daily mean values). Vertical lines: Timing of applying internal insulation and hydrophobization (water repellent agent). For some periods, some sensors contains no data, indicating that they are defect or the signal is unstable.

Measurements from inside the wall of daily mean temperatures (Figure 5a) all show similar trends and show temperatures within 7 °C of each other. The temperature is generally between 0-5 °C (winter) and 20-25 °C (summer). Temperatures tend to be lowest at 'bedroom north', which is to be expected having the north wall oriented towards the nearby coast and with minimum solar radiation. The highest temperature is seen in the utility room at south, however at spring only. In autumn, the highest temperature is seen in the window sill at west, being closer to the interior. In general, orientation of walls is more important than whether measurement takes place at a high or low position on a wall.

The relative humidity at the different positions develop very differently (Figure 5b). While relative humidity high in the east-oriented wall drops below 100 % almost at once, reaches 85 % after a year during a not very "drying" summer (2017) (section 5.1) and reaches 75 % after two years, showing seasonal changes, nothing seems to have happened at the west oriented wall, although it might be a defect sensor, since the sensor in the window sill on the same orientation illustrates a significant reduction in relative humidity. RH in the north oriented wall seems to be independent of the position of the sensor, not being the case in the east oriented; the sensor at low position does not even show any seasonal changes, questioning to some extent the results from this sensor as well. The orientation towards east results in solar radiation (opposed the north oriented bedroom) and less precipitation than towards west. The pattern of the relative humidity in the window sill at west, is comparable with what is seen at the east façade; the even earlier drop in relative humidity is explained by the position close to the interior.

The application of internal insulation alone seems to have no effect on the relative humidity, which starts to decline soon after the walls becoming hydrophobized. However, this effect is not seen at the south oriented wall until a year after the application, i.e. the beneficial drying conditions during summer 2018 and winter 2019 were not enough to dry out the wall. This indicates that the walls still contain built-in moisture 2-3 years after applying the internal insulation and that it takes a couple of years before the level at the east wall and the window sill is reached. Also notice, that even before the walls becoming hydrophobized, the interface in the east oriented wall (high position) becomes dryer than the window sill. The development of the moisture conditions might have looked different, resulting in lower relative humidity in the first two years after applying internal insulation, if a water repellent agent was applied in connection with the internal insulation as suggested by simulation results, seen in Figure 6.
