SBE21

Sustainable Built Heritage

Comprehensive energy renovation of two Danish heritage buildings within IEA SHC Task 59

Jørgen Rose^{1,2}, Kirsten Engelund Thomsen¹

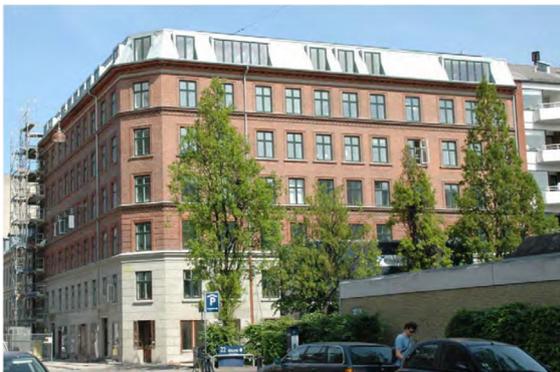
Figure 1. Façade of Ryesgade 30 after renovation including new roof and penthouse apartments. Ground floor has commercial premises.

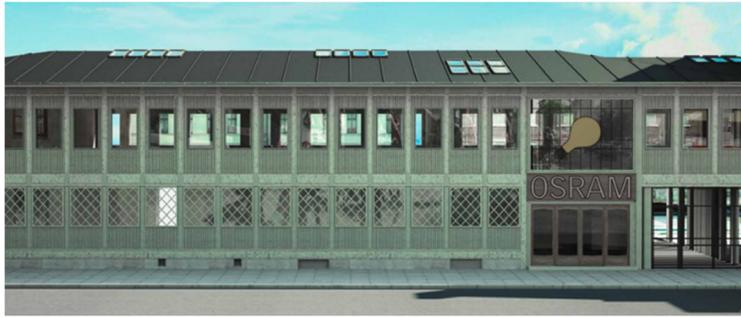
Figure 3. Façade facing the main street after renovation

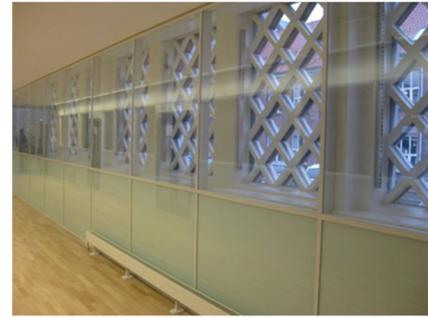
Figure 4. Façade facing inside after renovation

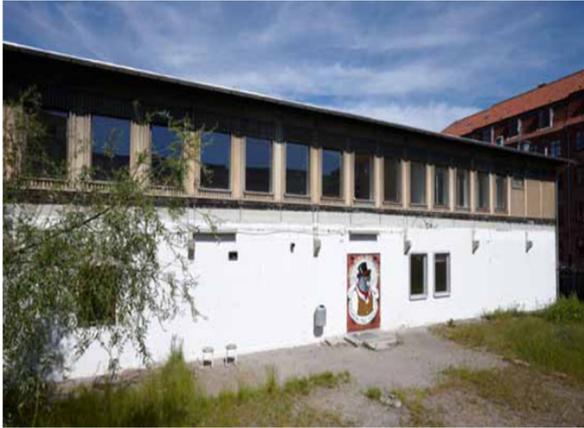
Figure 5. Façade facing garden before renovation

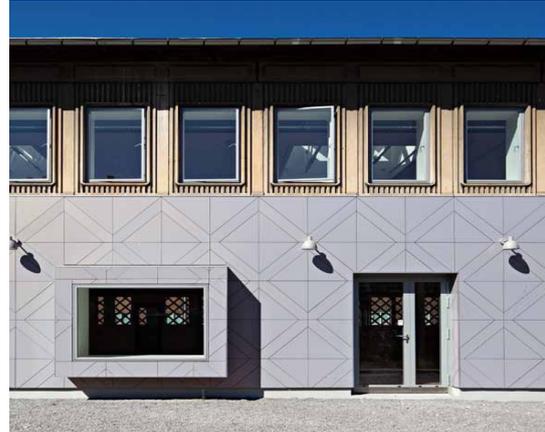
Figure 6. Façade facing garden after renovation

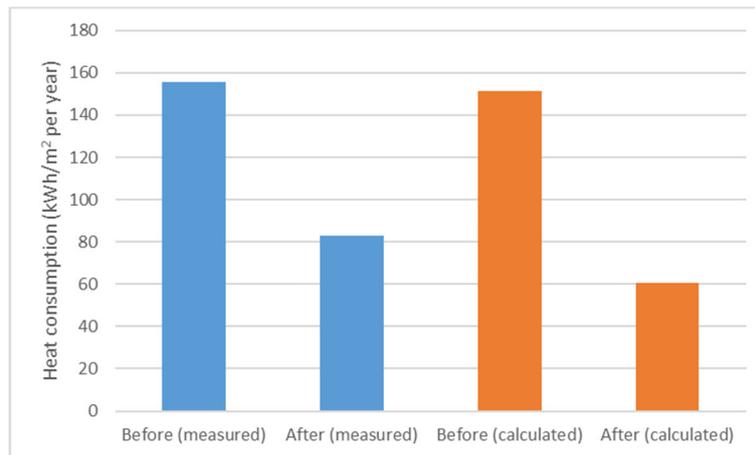
After the renovation the consumption was measured as 83.0 kWh/m² (September 2013 to September 2014) and during the same period the photovoltaic system produced approx. 11 000 kWh, corresponding to 3.3 kWh/m² per year. The electricity production was approx. 20% higher than expected. The IDA ICE model had predicted a heat consumption of 60.6 kWh/m² per year, so the actual consumption was significantly higher than expected. Figure 7 shows results of measurements and calculations.

Figure 7. Measured and calculated heat consumption before and after renovation of Ryesgade 30.

One of the main reasons for not achieving the expected savings in heat consumption was the fact that the indoor temperature after the renovation was significantly higher than what is usually used in these types of calculations. The temperature was measured during the heating season of 2013-2014 in blocks A and B (20 different sensors in total) and the result showed an average indoor temperature of 22.5 °C.

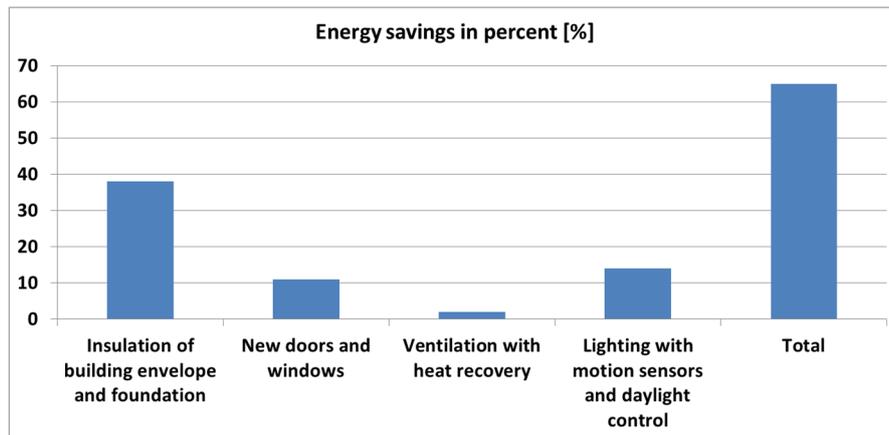
The energy savings for the building is 9 500 and 181 000 kWh per year for electricity and heating respectively. The savings from the façade insulation and the windows account for 150 000 kWh per year and the rest are from the heating- and lighting systems, the controls and the solar panels.

Figure 8. Energy savings in percent divided in the different parts of the renovation.
