SBE21

Sustainable Built Heritage

Sustainable Historic Architecture in Rural Areas – Concept for a sustainable and low carbon retrofit of a Bavarian farmhouse

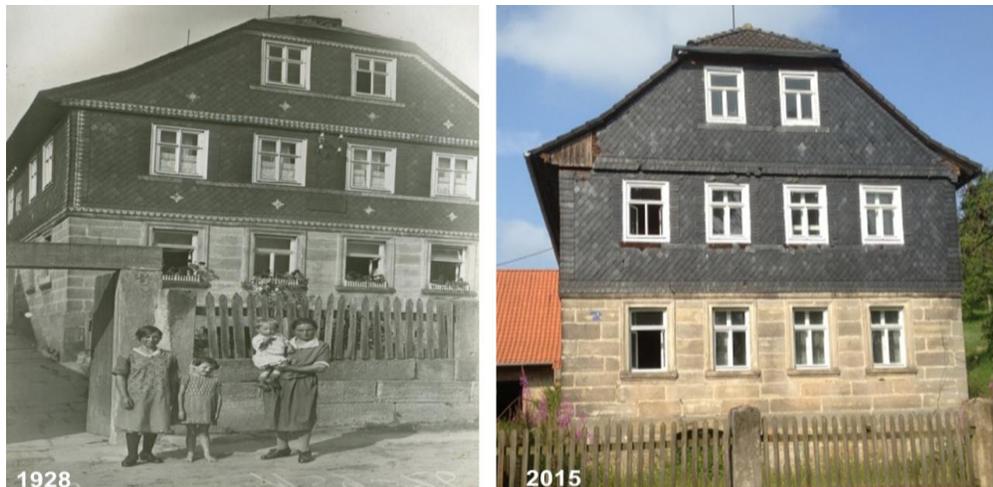
Image 1: Farmstead “H14” in 1928 and 2015 (pre-renovation)

The homestead “H14” is a typical Franconian three-sided building, which is composed of a residential building, a stable and a barn with an auxiliary building. The property is accessed next to the former cottage garden by a gate made of sandstone. The traditional “Sandsteintrieb” (sandstone ramp) guides one from the entry port to the main building and to the stable. A further entrance is located at the backside of the Farmstead and leads to the site of the former existing machine hall, which however collapsed in the past. Beyond the buildings used to be a meadow with fruit trees, fishing lakes and pastureland for the livestock. The complete property was overgrown and out of use for several of years.

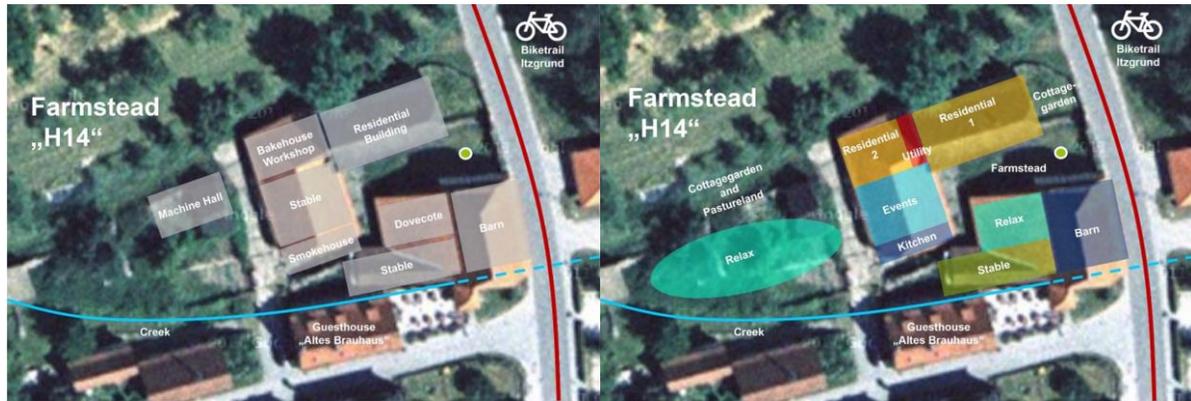
Image 2: Status quo “H14” (prior to the planning)

Image 3: Sustainability Goals “H14”

Prior to the start of the renovation an inventory was conducted in order to assess the building condition and develop coordinated renovation actions. In close coordination with the monument protection authority

and specialist companies, the following measures were performed: building deformation survey, restoration report, roombook, dendrochronology, archival research, static report, building physics report, action plan, and construction cost estimate.

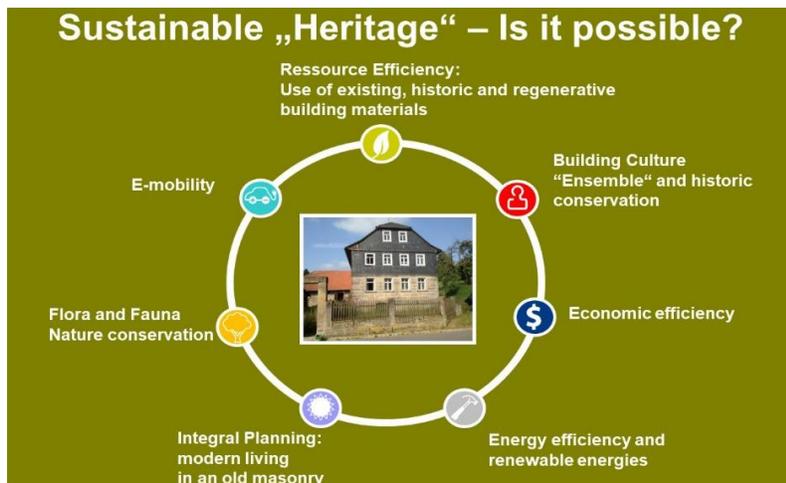
Image 4: Sustainability Concept "H14"

With the support of the district of Lower Franconia, the Bavarian State Foundation and the support from the compensation fund of the Bavarian State Ministry for Science and Art, a comprehensive renovation was implemented. The aim was to create a sustainable monument by means of a renovation concept suitable for historical monuments, renewable energies and the reuse of existing and regional materials. Under the motto of the holistic renovation approach "ecology, economy and social aspects" and "efficiency (better), consistency (different) and sufficiency (less)", the following planning goals were the priorities in the course of the renovation:

- Preservation and promotion of building culture in rural areas: "Learning from the past"
- Resource efficiency: use of historic, regional and regenerative building materials

- Energy efficiency: Resource efficiency: renewable energies, an energy concept tailored to the building and energy storage
- Integral planning: sustainable living and working in historic walls
- Economic efficiency and life cycle costs
- Revitalization of the cultural landscape: the overall ensemble (buildings and outdoor complex)
- Promotion of flora and fauna: biodiversity
- New mobility concepts for rural areas: e-mobility

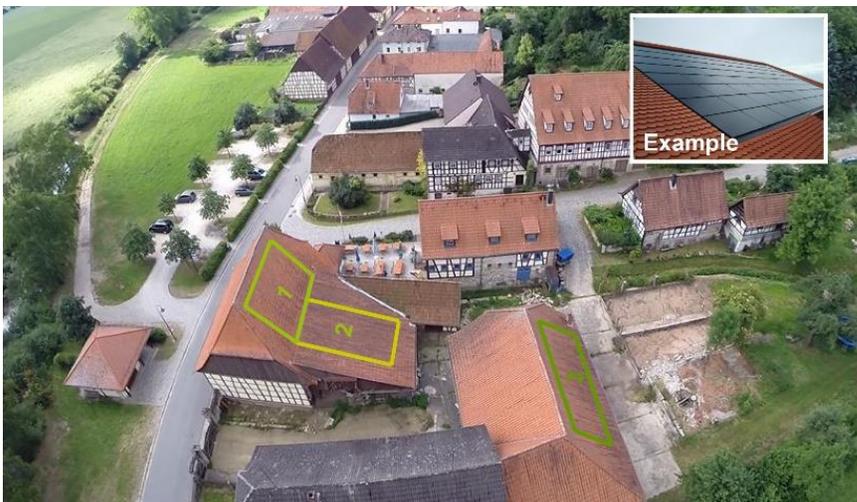
Image 5: Photovoltaic concept in cooperation with the monument protection authority

water heat pump for the base load and the use of multiple wood-burning stoves (partially water bearing). The operation of the air-water heat pump is supported by the electricity generated by a photovoltaic plant, which is hidden and integrated in the roof of the former dove cote (annex of the barn). The concept of the installation of the PV system was coordinated with the office for the preservation of monuments beforehand (see Image 5). In the future, battery storages and e-mobility are to be integrated.

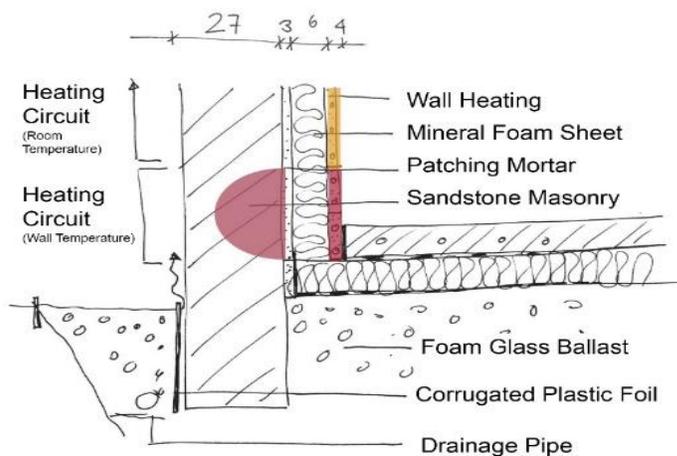
Image 6: Concept idea on building part tempering for protection against ascending humidity as per Großschmidt

The residential building is heated by a component activation in terms of the installation of wall heating on the outer walls on the ground and upper floor and floor heating in addition. The event room as well as the kitchen area are equipped with floor heating, which is integrated into the screed. Furthermore the main building can be heated with additional fireplaces. The existing fireplaces were refurbished. As a large section of the building does not have a cellar and was used as stables (salinization of the walls) and as there were no protective measures made against rising damp from the floor area, a thermal component activation on the basis of the tempering method as a horizontal barrier by Großschmidt was applied [2]. At the level of the base plate, an entire heating pipe was laid on the ground floor (see Image 6), which is heated all year round in order to prevent humidity from rising. With the software programme WUFI ® (Wärme Und Feuchte Instationär) different variants were simulated, in order to determine the moisture content in the sandstone masonry and in the lime plaster and to define the layout of the heating pipes (see Image 6 and 7):

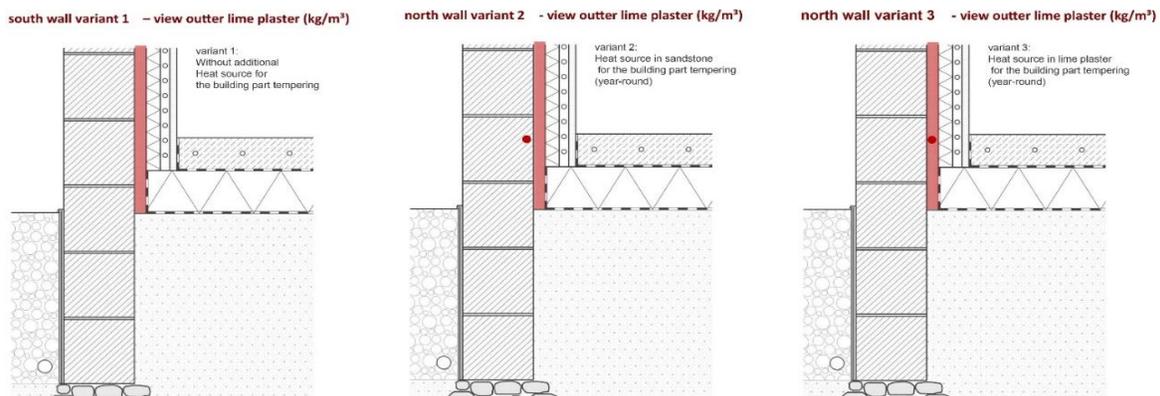
Image 7: Building part tempering variants for protection against ascending humidity

- Variant 1: without additional heat source
- Variant 2: heat source in sandstone
- Variant 3: heat source in lime plaster

Variant 3 was executed, as it was the easiest option to implement in terms of building construction. Furthermore, the thermal component activation is to be reassessed by a future monitoring.

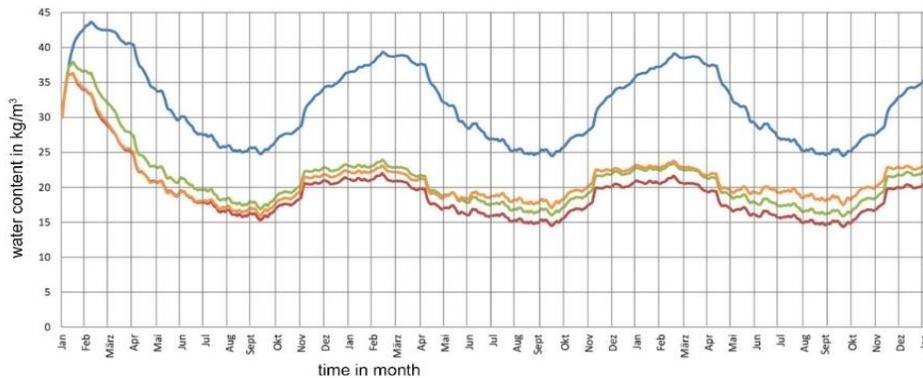
Image 8: Humidity simulation of the different variants of building part tempering

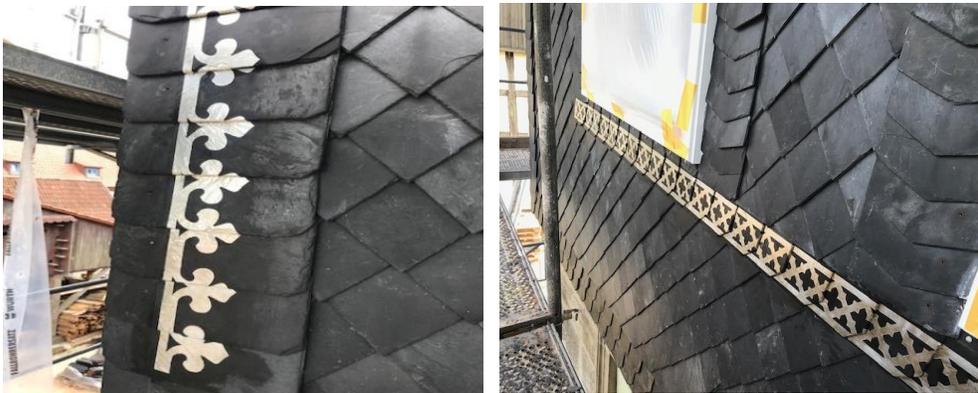
Image 9: Renewal of the slates

The facade of the upper half-timbered stories was re-slatted, largely using the old, rhombic shaped stones. In addition, the decorations on the slates were applied to the slate stones according to a historic template. Since this is an old craftsmanship and no specialist company could be found for the implementation, the client, together with restorers, newly acquired the craft. Appropriate patterns were cut out of tin foil and placed on the slate stones with a mixture of linseed oil. In earlier times, lead silver alloy was our tinfoil of today. Today it is a thin, rolled tin foil.
