SBE21

Sustainable Built Heritage

14-16 April 2021,
Online conference

Water absorption characterisation of historic plasters. Comparison of different methodologies in a case study in Tyrol, Austria.

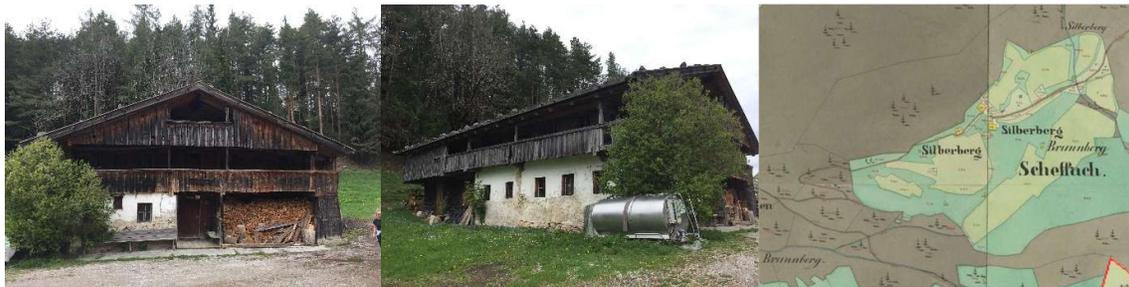
Figure 1. Pictures of the historic miners' hut in Reith im Alpbachtal, Tyrol, (A. Rieser) and the "Franziseisische Kataster" of the Habsburg Monarchy from 1855 (marked as "Silberberg")

The building is an extraordinary example of a “Knappenhütte” (miner hut) dating back to 1378. The building was directly linked to the copper silver mining in the area and served as an entrance to the shafts and lodge for the miners. In the last ten years, after being used as a mountain hut for the farmers during the summer months, it has been neglected. Currently, it is abandoned and in a poor state of conservation. Different recognisable construction phases and numerous layers of plaster provide information about the development of the building. Existing colour settings in the plaster suggest that parts of the rising building fabric still date back to the 16th century. Because of the fragility and the damages on the existing plaster, an extremely sensitive approach was necessary. The application of the measuring methods was accompanied by a relative chronological assessment of the plaster layers in order to make the results obtained comparable.

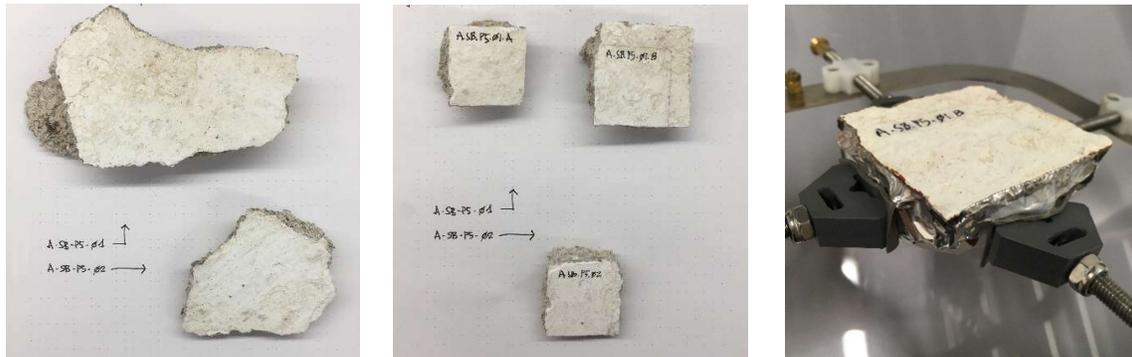
Figure 2. Elaboration of regular samples in the laboratory in preparation for the Free water uptake test

As limitations, it is worth highlighting that the number of locations and replicates tested was kept to minimum to limit the removal of material from a historic object. Material handling in the laboratory to produce regular sized samples (Figure 2) is a delicate and time-consuming task. To ensure the accuracy and reproducibility of the measurement, each test was carried out at least twice on every sample.

It is worth noticing the large variability of results also between different specimens of the same area or even same sample. Samples WU/P5/01/ A and B were prepared out of the same wall segment as shown in Figure 2 and yet the results diverge by a factor 2.

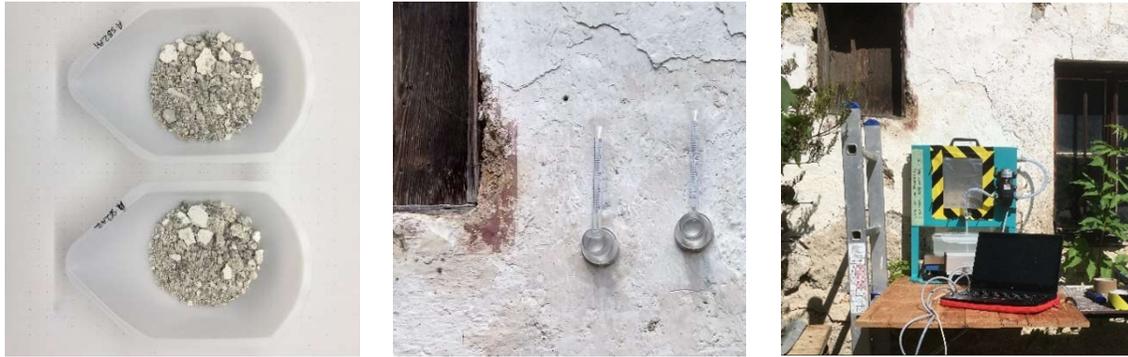
Figure 3. From left to right, samples for gravimetric analysis, Karsten tubes and WAM100-B

The gravimetric test, as described in [6], is used to determine the water content of a certain material. Powdered samples extracted on site are used to calculate the difference between the wet and dry mass of the sample. In this case, the test is used trying to infer the capillary absorption coefficient of the plasters. Samples (Figure 3) were taken immediately after an onsite test had been performed (see section 2.3) and from a dry nearby location. Considering the exposed area of the sample and the duration of the onsite test (that is, for how long the material was exposed to water), an estimation of the capillary absorption coefficient was calculated. Samples needed for this test are much smaller than those needed for the free water uptake test and could represent an alternative method in cases where access to samples is limited. On the other hand, this method presents some limitation as the test is not designed specifically for this purpose. Extraction of sample material with power tools can lead to water evaporation and samples must be transported to the laboratory to be weighed with an analytical scale. To prevent evaporation, samples were collected with a small chisel and a spatula and kept in sealed airtight bags.

The use of graduated plastic tubes attached to the wall with mastic allows the onsite measurement of water absorption. The tubes are filled with water and the level is registered at regular intervals. This non-destructive and simple method is described in [3] and has been used in numerous studies with comparative and analytical purposes [2]. For each tested location, at least two tests were carried out, however ensuring a full bonding of the mastic with the plaster was difficult (especially in cases where the plaster had been painted or whitewashed) and in many cases the results had to be discarded due to leaks between the tube and the wall.

The last method, described in detail in [4], is in line with the ASTM C1601 procedure and proposes the use of an ad-hoc apparatus to replicate the effect of wind driven rain onsite. The WAM-100B has a much larger sampling area (0.12 m²) and is equipped with a closed circuit of water that is sprayed on to the surface simulating a rain event. The amount of water absorbed is continuously measured by means of a dedicated scale and logging software. Like in the case of the Karsten tubes, ensuring a good bonding between the apparatus and the wall is key, but can be difficult on uneven surfaces. In this set up however, the test lasts 40 minutes and in some cases the tests must be stopped before their conclusion or the results have to be partially discarded. For the study described here, three tests were performed with very different results. One had to be discarded and a second one showed some leakage so only the data of the first half of the test was used.

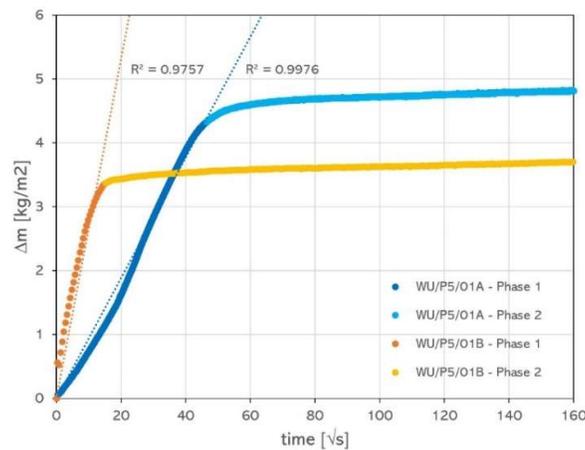
Figure 4. Free water uptake results (kg/m² against \sqrt{s}) of two specimens of the same wall sample

The ISO standard 15148:2002 [5] foresees three different types of outcomes when it comes to the resulting graphs of mass increase per area as a function of time (squared): (1) a straight line, (2) a straight line with a sudden decrease in slope, or (3) a curve of some form. The results obtained in the laboratory all lie within the second type, as illustrated in Figure 4. In those cases, the water uptake coefficient is calculated using only the values before the change in the slope. Despite the high difference between samples in terms of duration and mass increase, it is worth noticing that all samples presented a very strong correlation between $\Delta m/m^2$ and \sqrt{t} (see R^2 value in Figure 4). That is, the curve of water absorption against time (squared) followed a straight line during the first phase of the measurements.

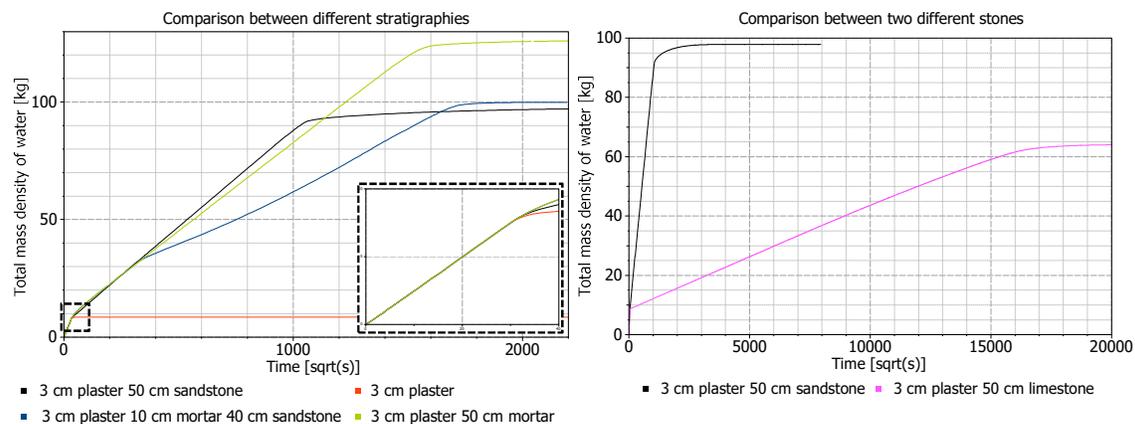
The left graph in Figure 5 shows the simulation results for four different build-ups: from just 3 cm of historic lime plaster, to a full wall stratigraphy with 3 cm of plaster, 10 cm of mortar, and 40 cm of stone. The zoomed area in bottom right corner of the graph clearly shows that the first phase of the water uptake does not change independently of the wall type. In all four configurations the water uptake follows the same trend and ends at the same point. It can also be noticed that one phase occurs after each other, as one layer saturates after each other. This becomes evident looking at the simulation with 3 cm plaster, 10 cm mortar and 40 cm sandstone, where three distinct phases can be detected, following perfectly what described in ISO 15148:2002 as Type B.

Figure 5. Simulation results for total mass density of liquid water (kg) versus time (\sqrt{s})

On the right-hand side of Figure 4, the curves of two simulated walls with identical build-up but different stones are presented. Sandstone and limestone show different slopes, as expected from the different water absorption coefficient of both materials ($0.0644513 \text{ kg/m}^2\text{s}^{0.5}$ and $0.00367 \text{ kg/m}^2\text{s}^{0.5}$ respectively). In the case of limestone, saturation is an extremely long process. This might explain the second slope observed in some of the samples measured in the laboratory. In Figure 4, it can be seen how the curve after the saturation on the plaster is not completely flat (as would happen in the case of monolithic samples) and continues to gain mass over time.

Therefore, and according to the results obtained with the simulations, if the calculation of the water absorption coefficient takes place before the external layer is completely saturated (approximately 20 min in this case), on site measurements can be a reliable method as they are not influenced by the remaining layers of the wall.
