**SBE21**

# Sustainable Built Heritage

# Evaluation of a retrofitted heritage building in downtown Cairo as a best-practice example

**Keywords** – Building envelope; energy use; energy retrofitting; field measurements; ‘La Viennoise’ building; Khedivial Cairo

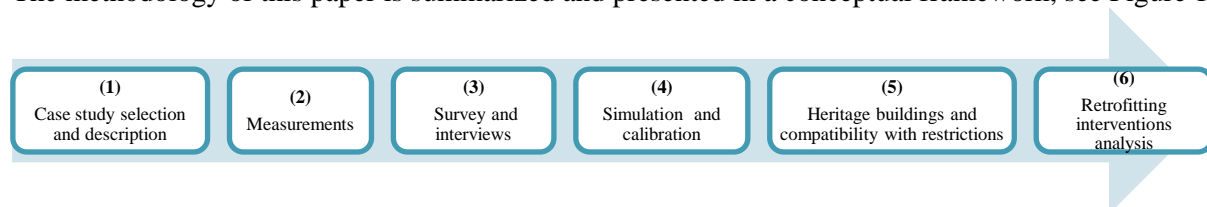
**Figure 1.** Conceptual framework of this study

The methodology of this paper is summarized and presented in a conceptual framework, see Figure 1.

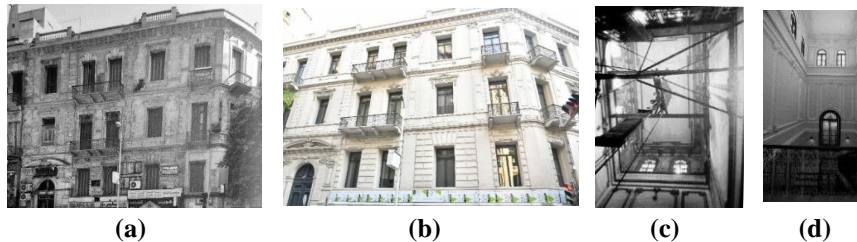
**Figure 2.** (a) Main façade before interventions, (b) main façade after interventions, (c) staircase before interventions, (d) staircase after interventions (first author's Ph.D. research)

Four criteria were used to select the building as a best-practice example: 1) a real retrofitted building, 2) the entire building was retrofitted, 3) the implemented retrofitting scenarios have met heritage value requirements, and 4) significant energy saving was achieved. These criteria were inspired by the work of Herrera-Avellanosa et al. [7]. Accordingly, ‘La Viennoise’ building on 7 Champollion Street in Downtown Cairo was selected as a case study, see Figure 2. The building was established in 1890s with

Italian-Renaissance-style. It is identified as a free-standing, forty-five-degree angle-shaped, and three-story building with load bearing walls construction system. It was originally built as an apartment house, then in 1928 was turned into a hotel [14]. Afterwards, it was subjected to much negligence for a few decades, until owned by Al Ismaelia Company to upgrade and re-use it with a new function.

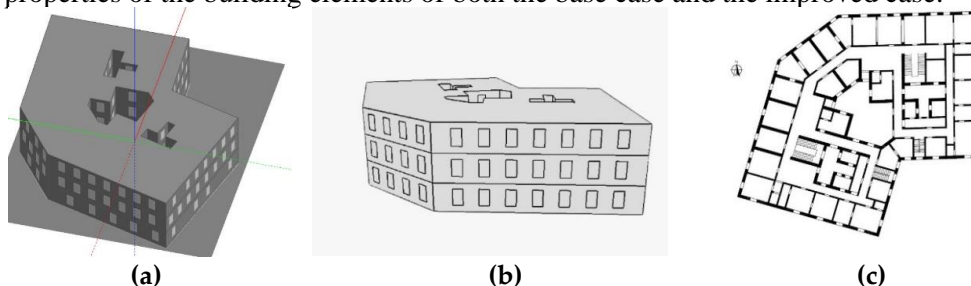
**Figure 3.** (a), (b) 3D perspectives of the model and (c) typical plan (first author's Ph.D. research)

Based on the collected data, a virtual 3D model was created by using DesignBuilder software, see Fig.3. Table 1 shows the input data used for the building simulation and modelling, and Table 2 shows the thermal properties of the building elements of both the base case and the improved case.

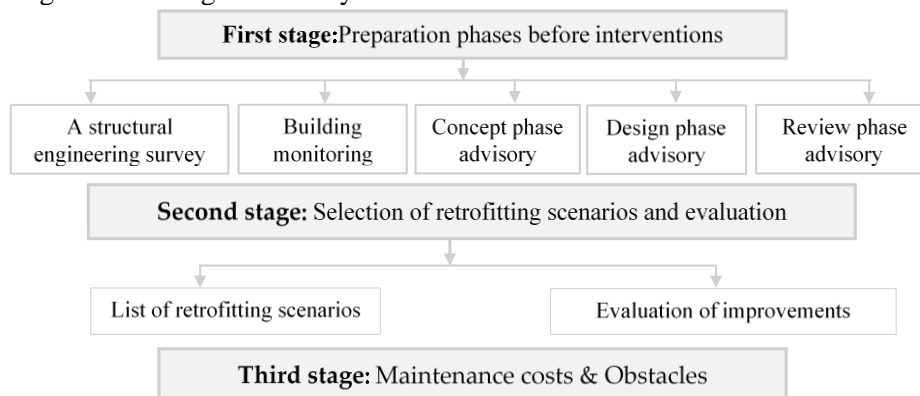
**Figure 5.** Flow chart of the implemented retrofitting procedures

A summary of the investigation and retrofitting procedures is presented into three stages in a flow chart as shown in Fig 5. These stages are analyzed and articulated into subsections as listed below:
