SBE21

Sustainable Built Heritage

Integrating thermal and mechanical characteristics of historic masonry categories: development of a Sicilian database

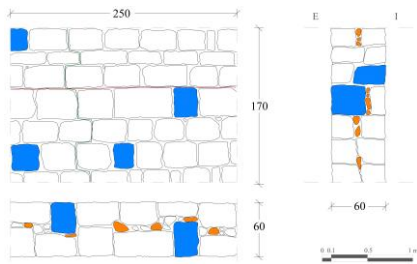
Table 2. Stone masonry typologies in Petralia Sottana. Orange is used for regularization elements, blue for headers. Red and green lines show the geometry of horizontal and vertical joints, respectively.

Masonry typology		IQM
SM1

Vertical loading 10 Horiz. in-plane loading 8.5 Horiz. out-of-plane loading 9
SM2.1

Seven masonry typologies have been identified. One type is characterised by regular courses of almost cut-edge stone units (SM1). Two recurrent bonds were distinguished in walls with less regular stone units (SM2), mainly differing in continuity and regularity of horizontal joints. Two typologies were identified also about rubble masonry (SM3), especially for the average dimensions of stone units. The two typologies of brickwork (BM) are not examined in this paper. The construction schemes of stonework typologies and the corresponding Masonry Quality Index are shown in table 2.

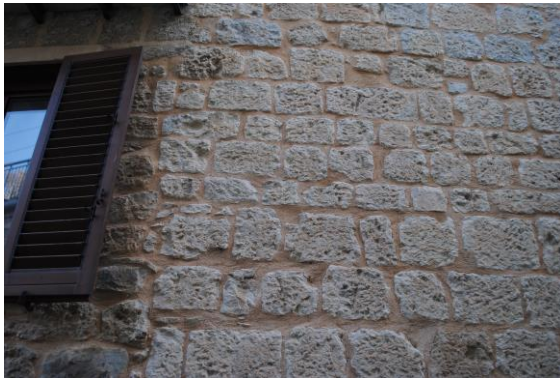
Figure 1. South-oriented façade with mp1.

Three in-situ measurements of thermal conductance were carried out during winter 2019-2020 in two historic buildings (figures 1-4): a house (measuring point mp1) and a public office (mp2 and mp3).

In the private house, stonewall is made of conglomerate and its type is SM2.1. The North-oriented façade of the building was not suitable for the test, because insulated from the inner side. This condition is frequent in Petralia Sottana and reduces sensibly the choice of measurement points. The test was carried out on a 47-cm-thick wall (plastered only on the inner side), oriented to the South but constantly protected from direct solar radiation by neighbouring constructions. The inner side of the wall faces a living room, regularly heated during the test by means of a radiator.

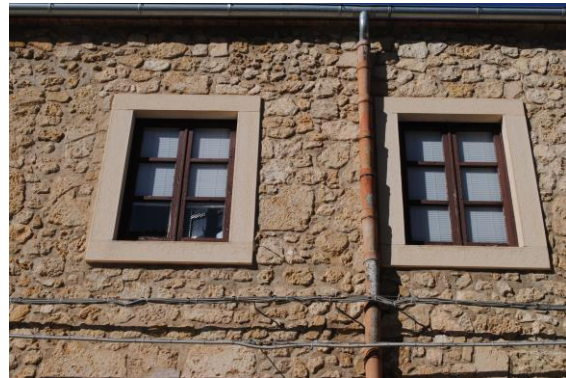
Figure 2. West-oriented façade with mp2.

The main façade of the office building, oriented to the West, is classified as SM3.2 and is a mix of conglomerate (prevalent) and quartz sandstone. The short northern façade is not accessible and shows heavy transformations of masonry arrangement. Since the West-oriented wall is subject to solar radiation, a second measurement was carried out on the opposite façade. Although this is plastered on both sides, it is reasonable that masonry typology is the same of the western façade, according to the information collected about the history of this building. Both tested walls are plastered on their inner side, which faces the following spaces, heated by radiators: a office occupied by a single worker for the 73-cm-thick western wall, a corridor for the 71-cm-thick eastern one. Table 5 reports the duration of each measurement and the resulting thermal conductance.

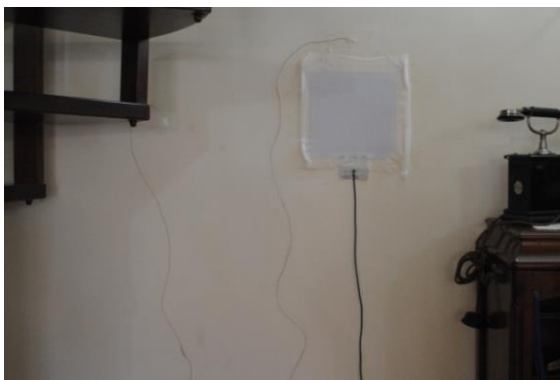
Figure 3. Heat flow meter in mp1.

In Petralia Sottana, where preliminary tests were conducted, the measuring apparatus was made of: data logger Ahlborn Almemo 2690-8, heat flow sensor (plate FQA 119, 250 mm x 250 mm x 1.5 mm, substrate in epoxy resin), four thermocouples (Cu-CuNi). The heat flow sensor was applied to the internal side of the wall through paper adhesive tape and protected by means of a light gauze. Paper tape was used also for thermocouples indoor. Outdoor, sensors were covered with a thin layer of gypsum paste, easy to remove but more reliable than tape on irregular surfaces and in case of rain (tested walls were not protected by overhangs). Before fixing the apparatus, measurement locations were inspected by means of infrared thermography. The recording interval was 150 s. Collected data was analysed according to the average method described by ISO 9869-1.

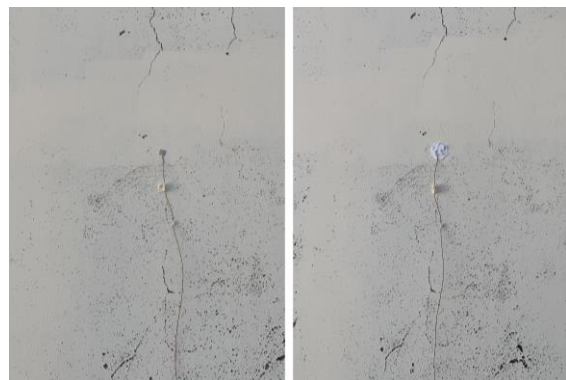
Figure 4. Outdoor thermocouple in mp3, before and after application of gypsum paste.
