SBE21

DRAFT PAPER

Deep renovation of an old single-family house including application of an water repellent agent – a case story

E J de Place Hansen^{1,2}, T K Hansen¹ and V Soulios¹

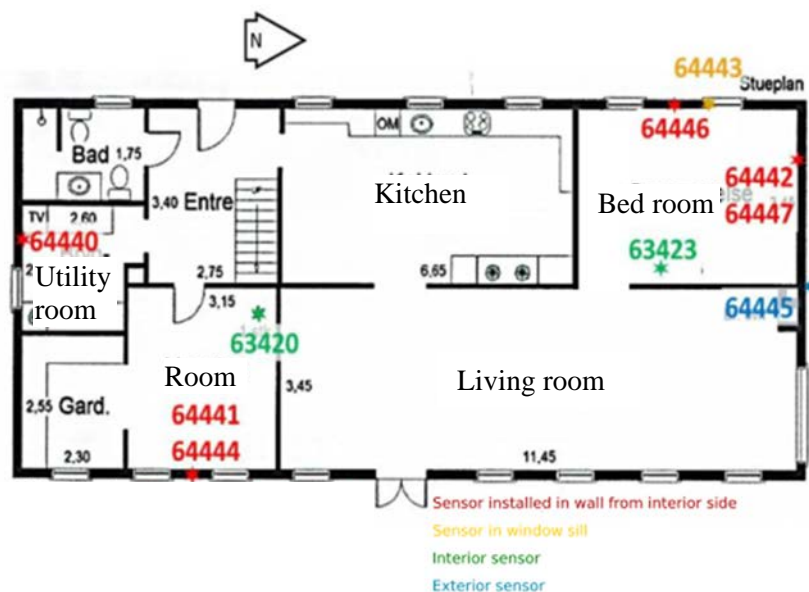
Sensors measuring relative humidity (RH) and temperature (type Tramex Hygro-i) every 30 minutes were installed in all exterior walls at the ground floor, in the interface between masonry and insulation, except for one sensor placed in the window sill, about 1,65 m above floor (Figure 3). In addition to the build-in sensors, reference sensors measuring RH and temperature were placed inside and outside the house (type climaSpot). At those locations where two sensors are shown in Figure 3, one is placed 50 cm above the floor and the other one 180 cm above the floor (50 cm below the ceiling).

Figure 3. Sensor monitor points at ground floor (original layout, both living room and kitchen later split into two rooms). In the interface between original wall and internal insulation (red, Tramex Hygro-i sensor), in a window sill (yellow, Tramex Hygro-i), indoor climate (green, climaSpot), and outdoor climate (blue, climaSpot). Numbers refer to sensor IDs.

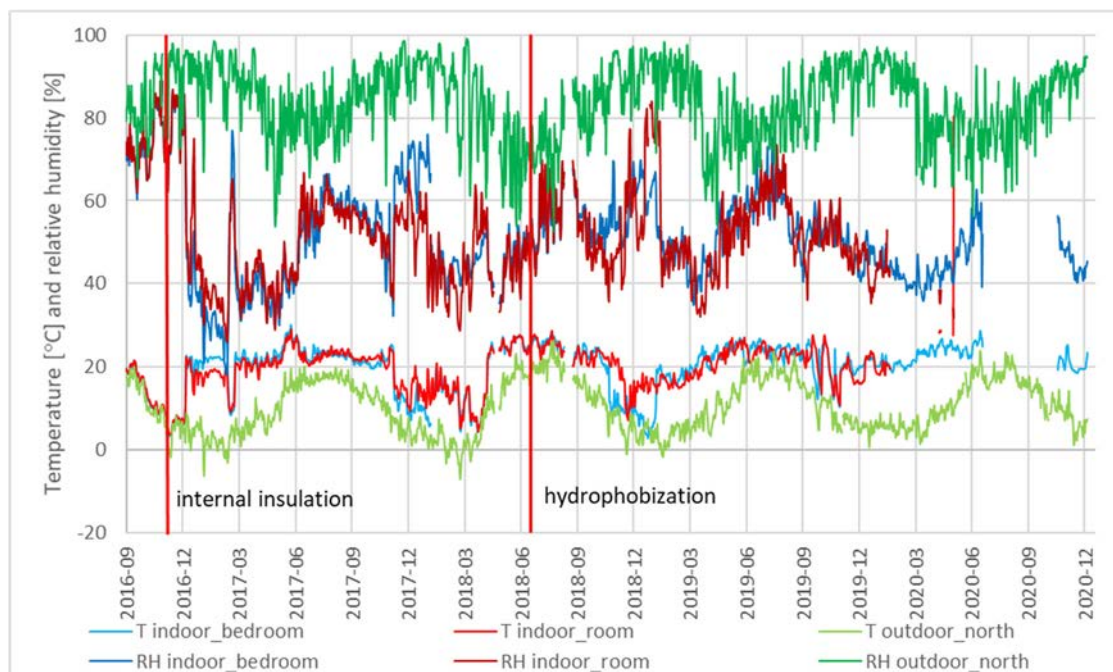
Figure 4. Indoor and outdoor temperature and relative humidity (RH). Daily average values from September 2016 to December 2020. Indoor measurements in the bedroom (blue curves) at northwest corner (Figure 3) and the room at east façade (red curves).

While the outdoor temperature and relative humidity (Figure 4) follow the seasonal changes with some deviations, e.g. a wet, not so sunny summer (2017), a dry sunny summer (2018), or a wet mild winter (2019-2020) [7], the pattern of the indoor relative humidity (and to some extent the indoor temperature) is not quite typical. The measurements started before the renovation was finished in early 2017, explaining why indoor and outdoor measurements for the first 6 months are alike; the heating was not yet turned on. In 2017, the owner had problems with controlling the heating, giving rise to temperatures quite far from the scheduled 21 °C, while later the use of the house mainly heated during weekends may explain extremes. The wet, not so sunny summer 2017 [7] had a lower drying potential than what can be expected. The following winter 2018 had conditions as they can be expected. A moist construction

therefore experienced minimal drying effect in 2017-2018. Opposed to this, 2018-2019 was a better period in terms of drying conditions; a dry summer followed by a warm winter (2019). This insight will be beneficial in evaluation of the walls condition (section 5.2).

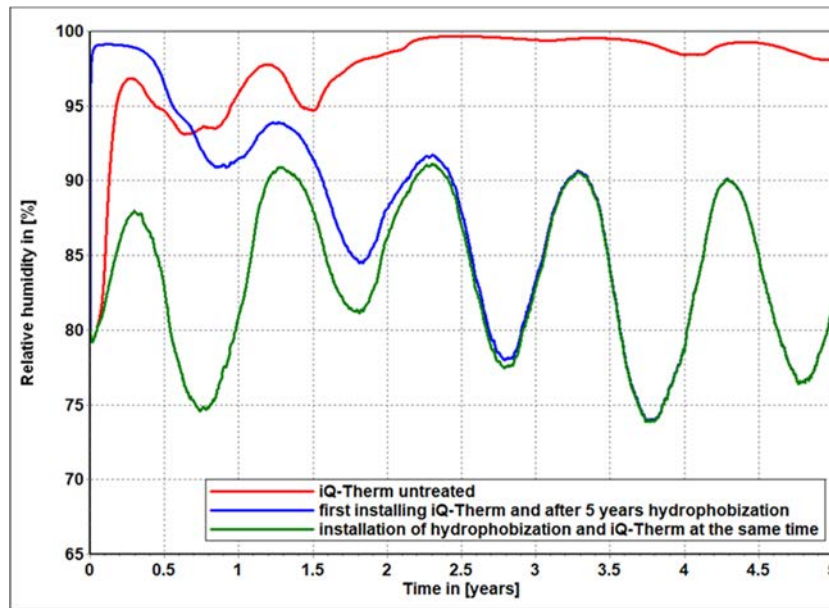
The application of internal insulation alone seems to have no effect on the relative humidity, which starts to decline soon after the walls becoming hydrophobized. However, this effect is not seen at the south oriented wall until a year after the application, i.e. the beneficial drying conditions during summer 2018 and winter 2019 were not enough to dry out the wall. This indicates that the walls still contain built-in moisture 2-3 years after applying the internal insulation and that it takes a couple of years before the level at the east wall and the window sill is reached. Also notice, that even before the walls becoming hydrophobized, the interface in the east oriented wall (high position) becomes dryer than the window sill. The development of the moisture conditions might have looked different, resulting in lower relative humidity in the first two years after applying internal insulation, if a water repellent agent was applied in connection with the internal insulation as suggested by simulation results, seen in Figure 6.

Applying a water repellent agent at the same time (green curve) as applying this type of internal insulation, showing capillary behaviour to some extent – or better, before applying the internal insulation – can accelerate the drying of the wall sufficiently to get rid of the built-in moisture, as it eliminates moisture penetration from wind-driven rain. In the long run, though, hydrophobization will still be beneficial even if done at a later stage (blue curve), as doing nothing (red curve) will keep the relative humidity at a very high level. In accordance to simulations performed in [8] the hydrophobization in Klitgaarden was applied in the optimal season with regard to drying of the wall. While the timing for applying a water repellent agent might not be that important when using PUR-foam with capillary active channels (iQ-Therm), as long as it is done after some time, on the contrary, the timing is very important in the case of applying a vapour tight insulation system (e.g. mineral wool and a vapour barrier). In this case, hydrophobization has to be applied no later than the internal insulation to avoid moisture problems at the early stage (Figure 7), but it is still positive in the long term if done after e.g. five years. This phenomenon has been further studied in [4], showing that in the case of calcium silicate based insulation, being capillary active, hydrophobizing the wall in parallel with the internal insulation or five years later, gives almost the same result. In line with the findings of the current paper, previous studies based on numerical results, reported that the hygrothermal performance of an internally insulated facade can be improved by hydrophobization [8, 9].

Figure 6. Simulation of relative humidity in the interface between internal insulation (iQ-Therm) and solid masonry in SW-oriented wall configurations for a five year period, when no water repellent agent is applied (red curve), then after five years becoming hydrophobized (blue curve), and if internal insulation and hydrophobization takes place in parallel (green curve). The blue curve should in principle be shown at a 5-10 year scale as it starts where the red curve ends, using the average relative humidity of the internally insulated wall as initial condition for the simulation, but for comparison with the other curves, it is shown on a 0-5 year scale. Simulations were performed with DELPHIN software [3] with climate data for Copenhagen 2020-2024 (www.climateforculture.eu). Characteristics of an untreated and hydrophobized wall were based on [5] for the hygric properties and [4] for the hydrophobic model.

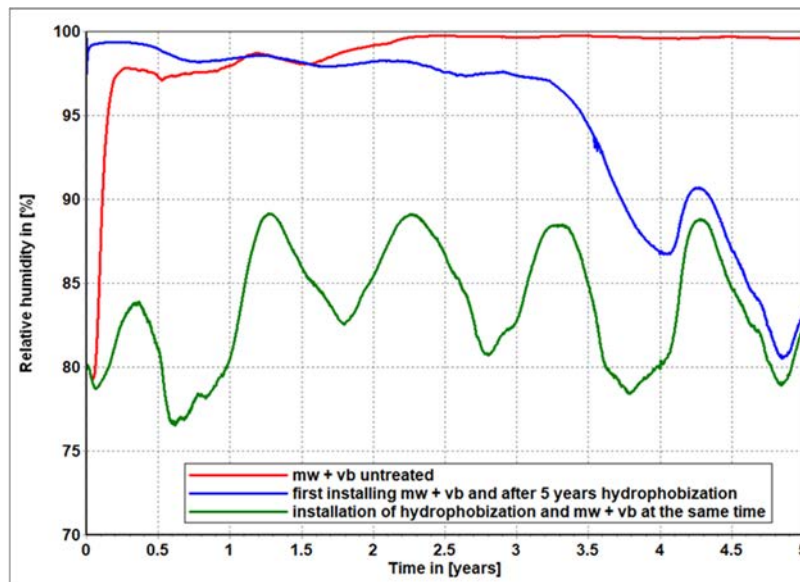
Figure 7. Simulation of relative humidity in the interface between internal insulation (mineral wool with vapour barrier) and masonry, in SW-oriented wall configurations for a five year period, when no water repellent agent is applied (red curve), then after five years being hydrophobized (blue curve), and if internal insulation and hydrophobization takes place in parallel (green curve). Concerning the blue curve, refer also to figure 6. Simulations were performed with DELPHIN software [3] with climate data for Copenhagen 2020-2024 (www.climateforculture.eu). Characteristics of an untreated and hydrophobized wall were based on [5] for the hygric properties and [4] for the hydrophobic model.
